Near Miss and Serious Nonfatal Accidents Metal and Nonmetal Mining

September 2013 through December 2014

NEAR MISS AND SERIOUS ACCIDENTS

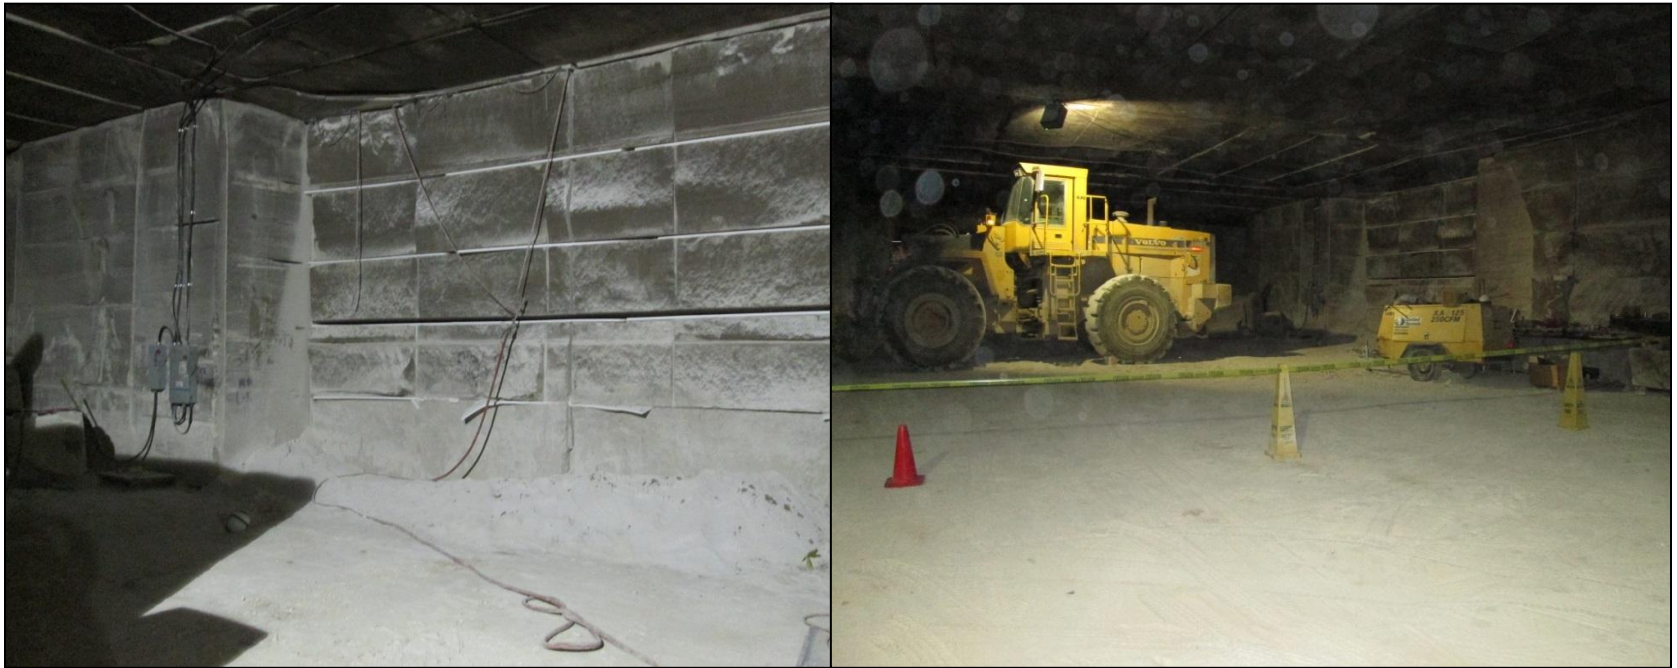
December 11, 2014

Underground Limestone Mine – A miner climbed a cut dimensional stone face by hand without any fall protection equipment. While climbing, he lost his footing and fell backwards onto a limestone floor, striking his head near his temple, which caused him to become unconscious. The injured miner was transported to the hospital by ambulance.

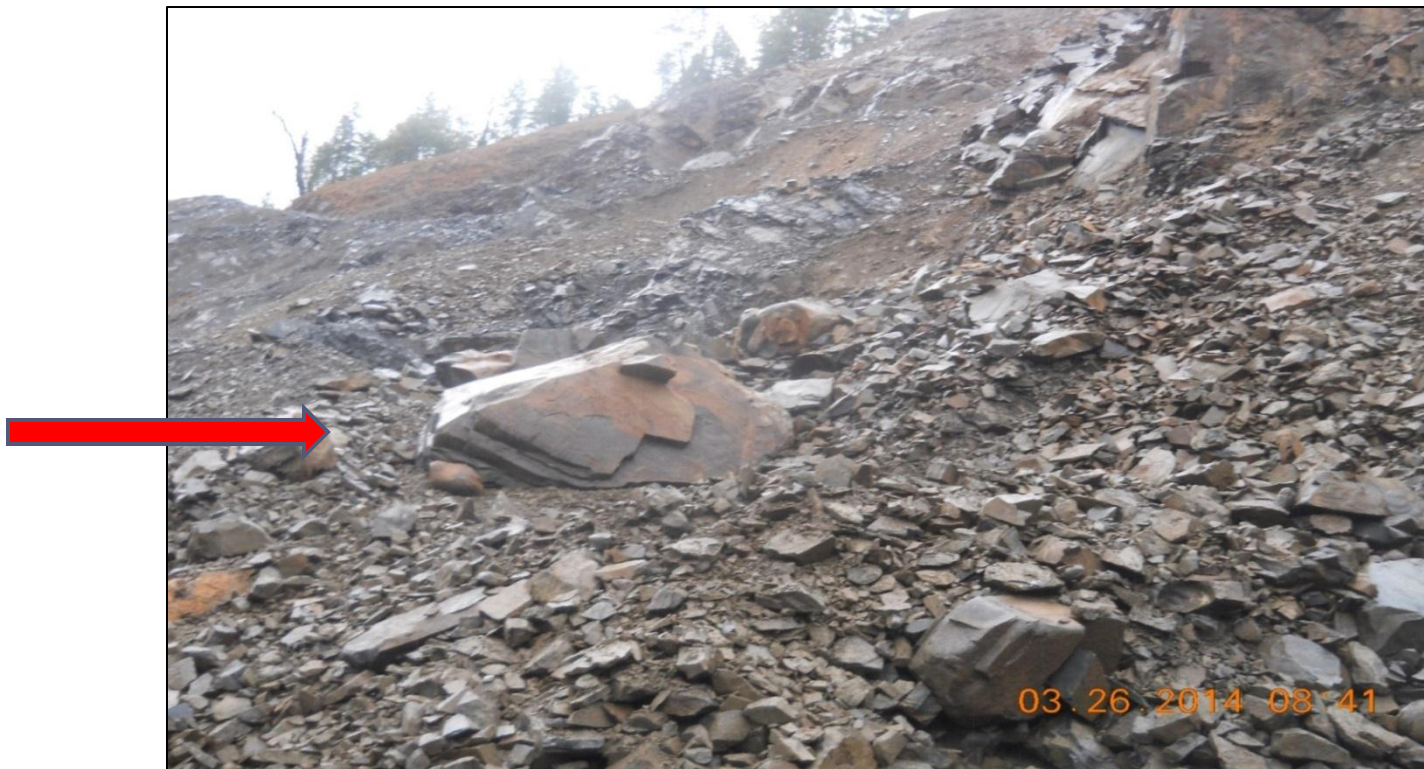
March 26, 2014

Crushed & Broken Traprock mine – An equipment operator was walking an excavator past a highwall when a large rock slide occurred covering the roadway. The operator passed the area within seconds of the slide.

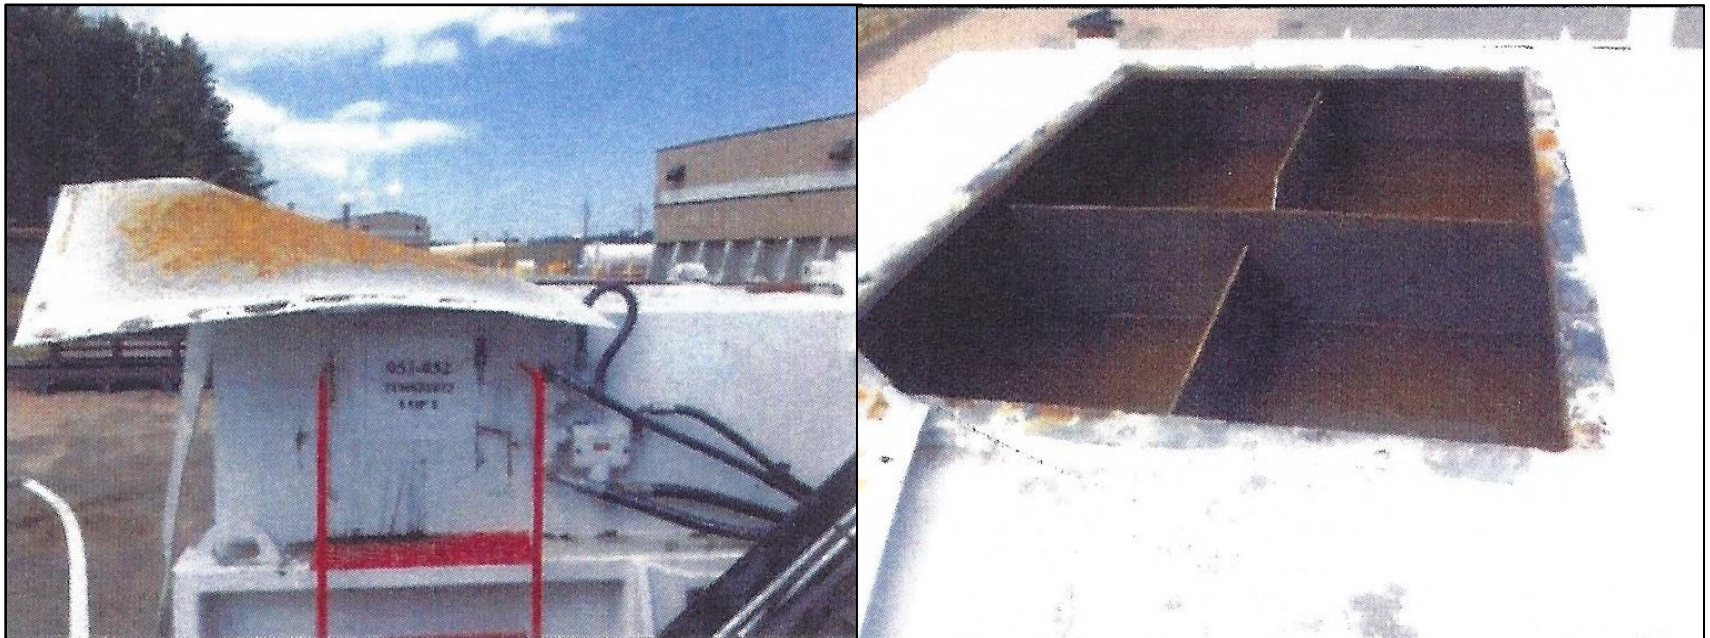
August 8, 2014

Copper-Nickel mine – A contractor employee filling a water truck using a fire hose was nearly struck by the metal top of the water tank when the attachment bolts failed under the pressure of the water. The employee was standing on the truck deck monitoring the tank level sight glass. When the tank reached the full mark, the bolts holding the top cover of the tank failed, and the water pressure peeled the metal back, just missing him.

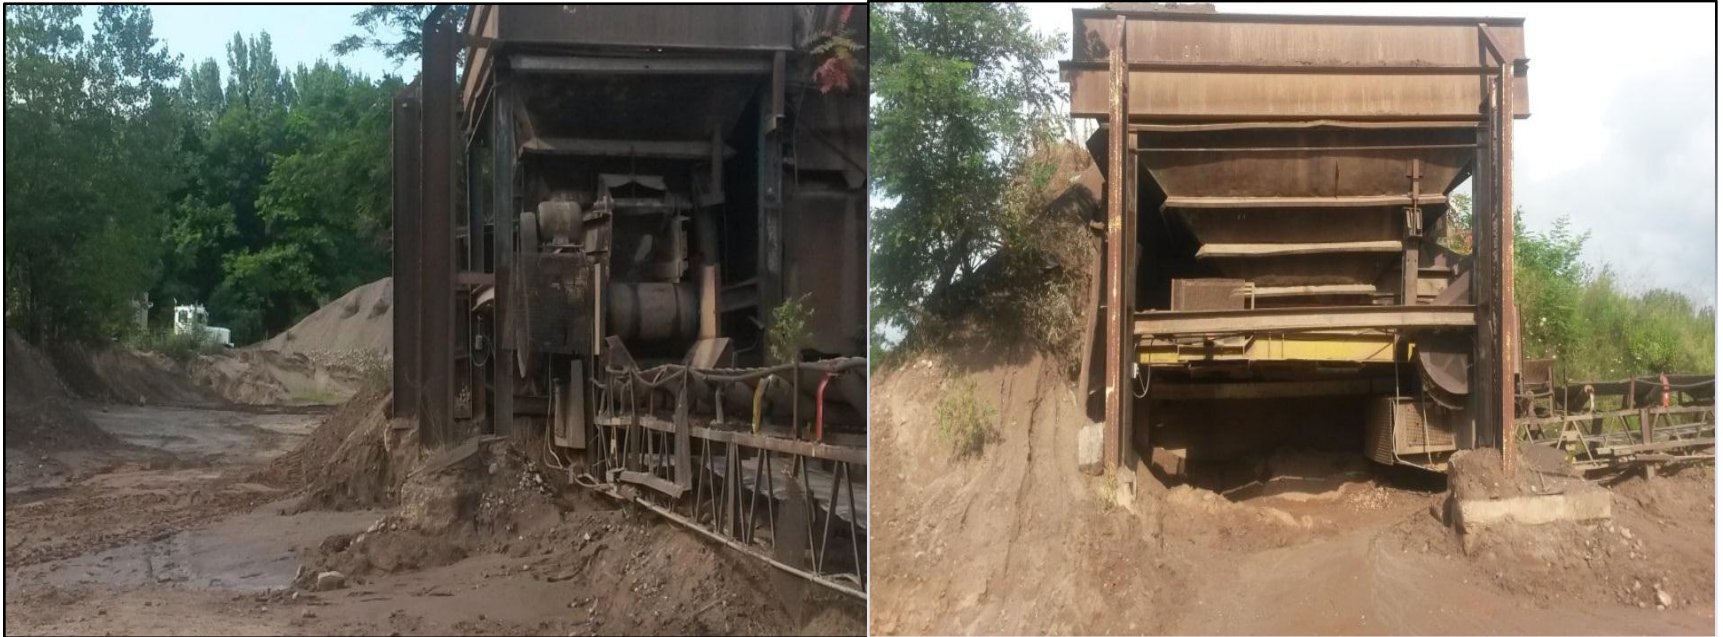
August 11, 2014

Sand & Gravel mine - Four miners were walking treadmill style on a moving feed conveyor while attempting to dislodge the plugged material inside the primary feed hopper. One miner was completely engulfed by sliding material, and another was covered up to his waist. After shutting off the feed conveyor the other two workers were able to dig out the two covered miners. All four escaped with minor cuts and bruises.

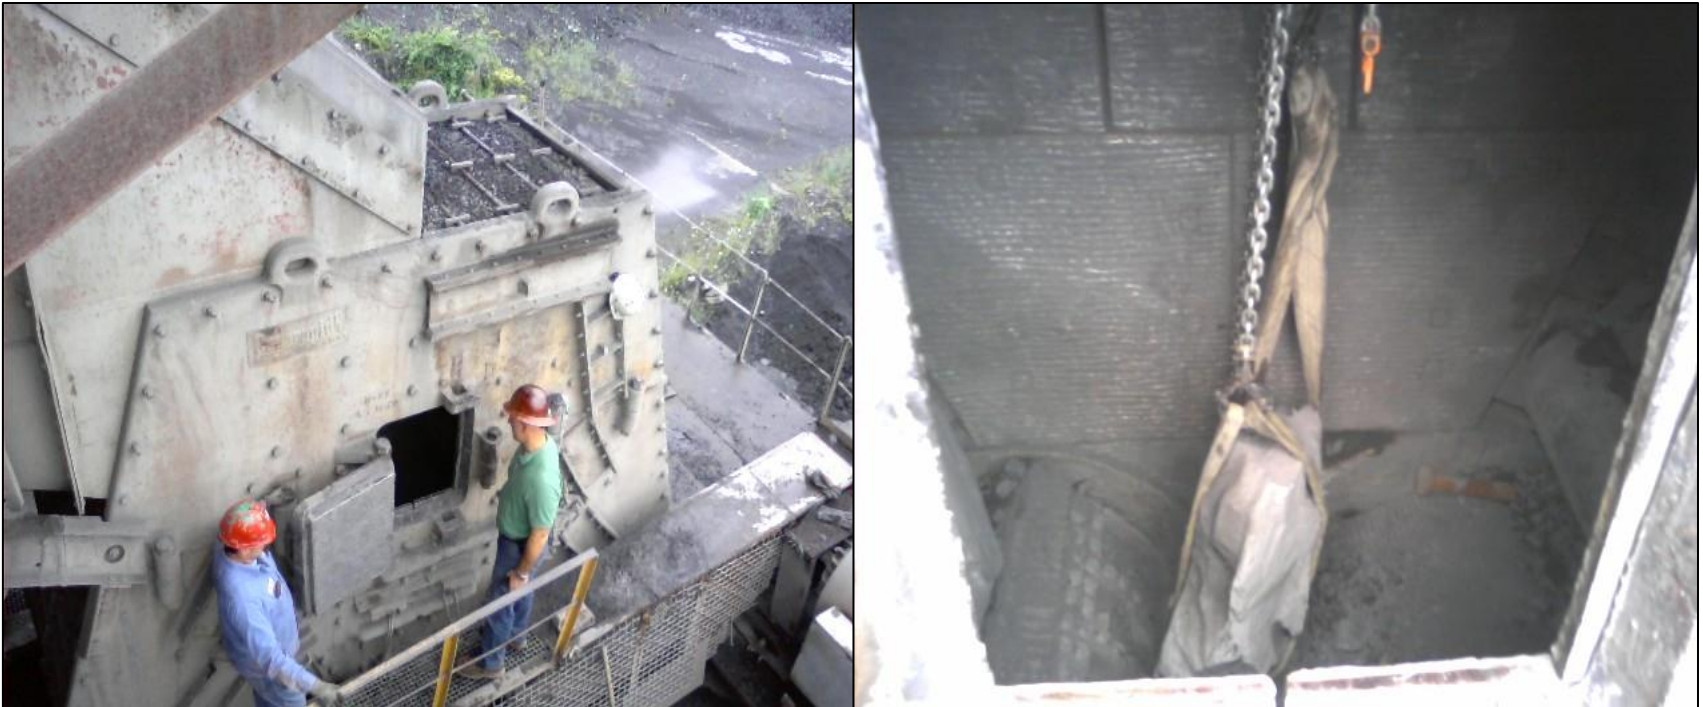
August 12, 2014

Crushed & Broken Stone mine – After a miner entered the impact crusher to remove a blockage, rocks fell from the feeder above and engulfed him up to his knees. He was freed and transported by EMS to a local hospital.

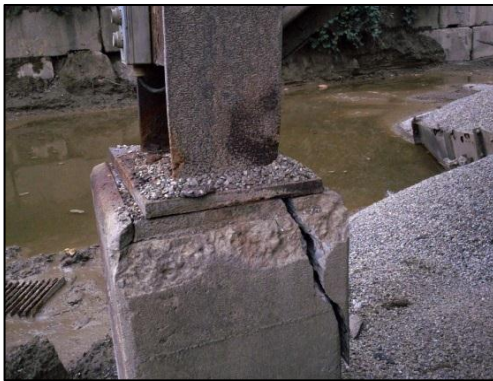
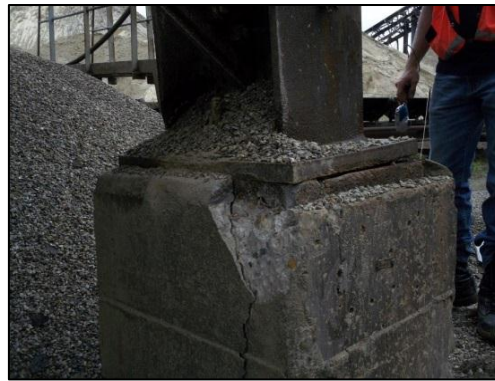
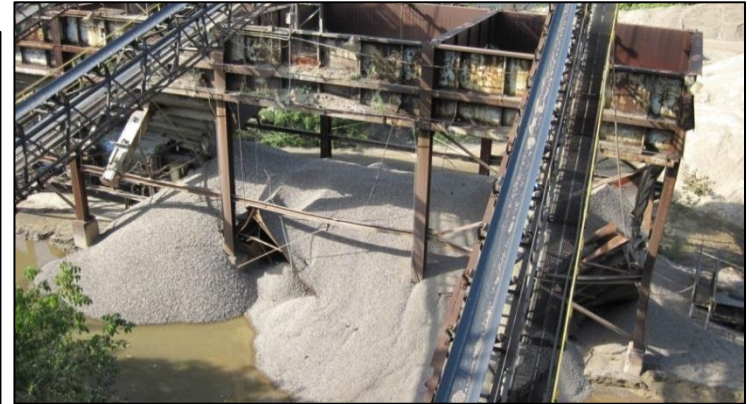
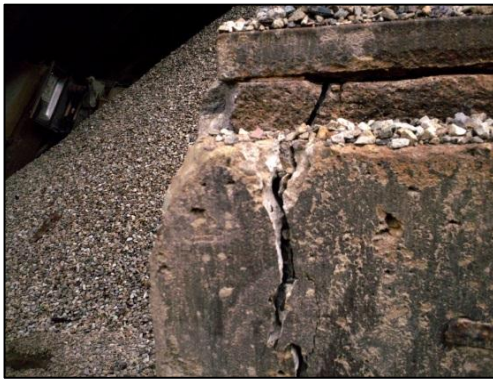
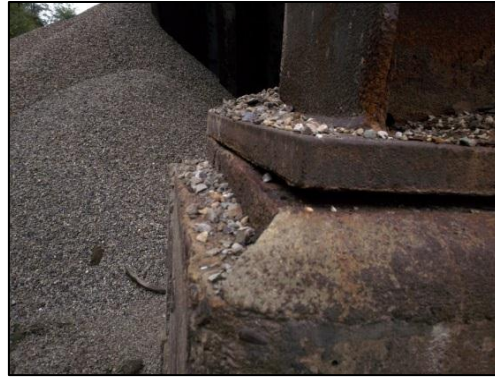
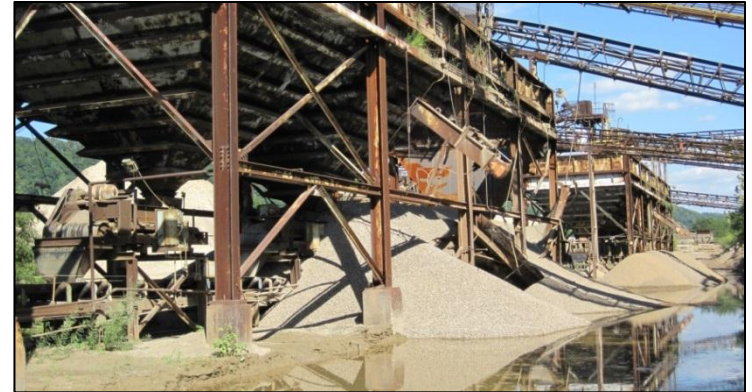
September 5, 2014

Surface Sand & Gravel mine – Structural defects in a primary plant caused a portion of the plant to collapse, including three material bins. There were no injuries.

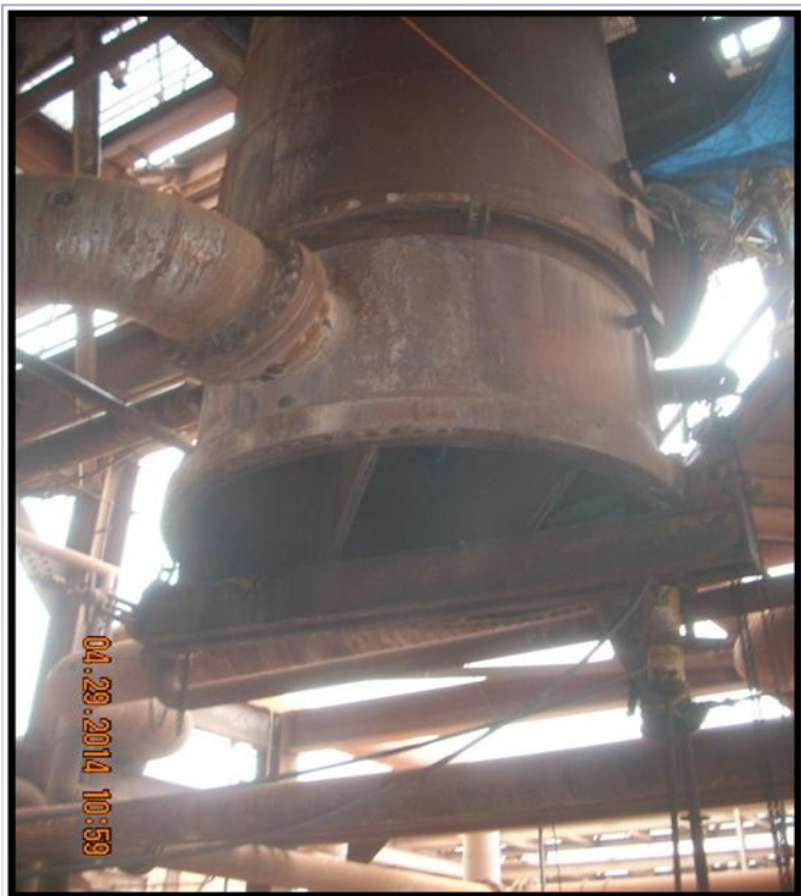
April 2014

Surface Alumina operation – Nine contractor employees were exposed to high levels of mercury while replacing cooler piping in a heater unit.

Contractors were standing beneath the heater when mercury fell on them.

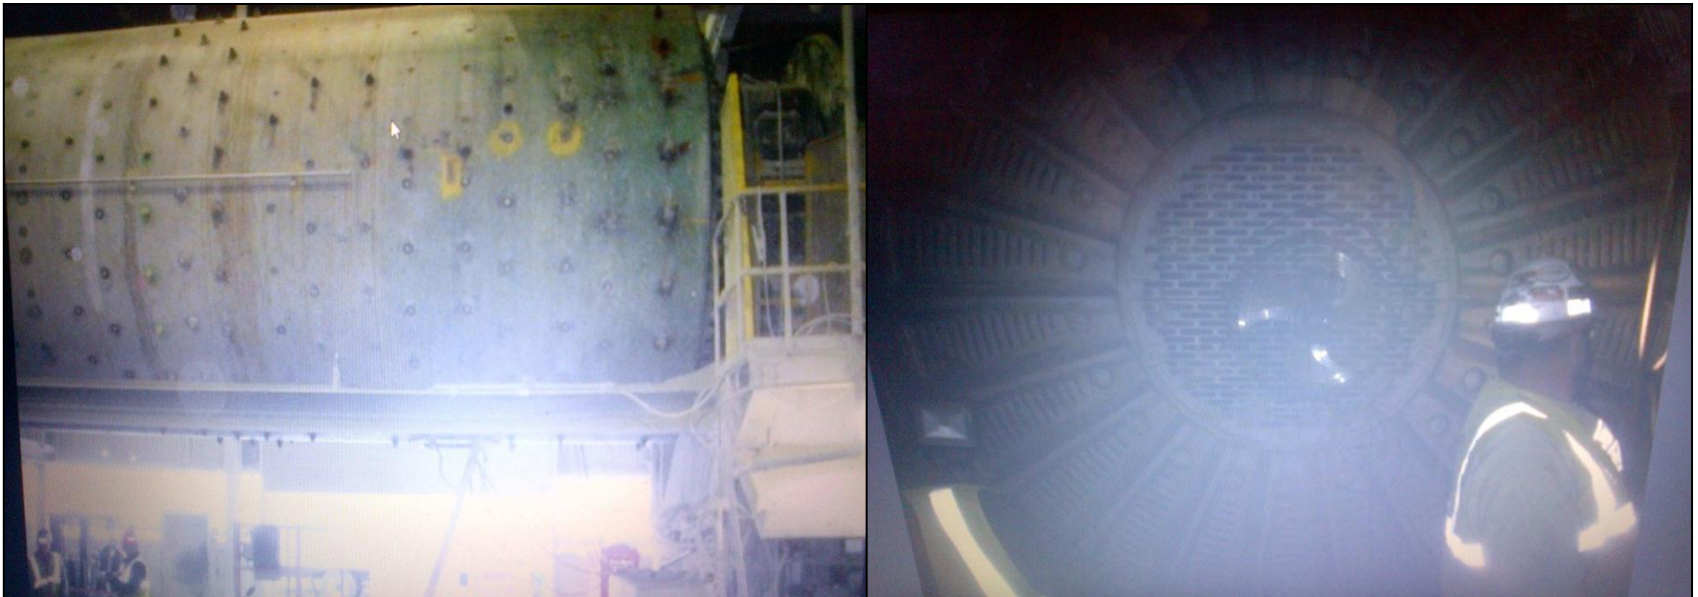
December 3, 2014

Cement Plant - During the mine's maintenance shutdown, five contract employees air arc-cutting magnesium liner plates inside a ball mill were treated at a hospital for symptoms of carbon monoxide overexposure. All five of the employees were treated and released.
